**Flood Control Project Maintenance
Levee Inspections**
LMA District Cover Sheet
Spring 2020 Levee Inspection Results

Sacramento River West Side Levee District

Spring 2020 Levee Inspection Results

Waterway			Bank	Unit Miles
Unit No. 01 Sacramento River			Right	49.64
	Spring (March - May)	Summer (June - August)	(September - November) Fall	Winter (December - February)
Unit Maintenance Rating (Fall Only)				
Date of Inspection	3/24/2020 - 3/24/2020			
DWR Inspector	Zach Jojola			
Accompanied By	Gary Marler RD0108

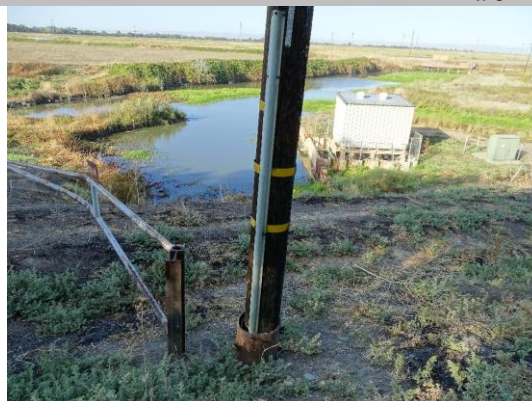
Photo 1 of 3 : UCIP_SP_2020_55790_82901.jpg

Comment Code						
Inspector Comment						
DS_ID:20223 FS_ID:55790 EP_NO: 12149 Repair Type: Non-Urgent Crossing Status: Found UCIP Comments: 9/30/2019 Record updated from No Action Needed to Non-Urgent. Telephone cable is disconnected on the pole. If telephone line is abandoned has to be done properly. (O.Yakimov - DWR UCIP) FIELD_STRUCT_DESC: 1.5-inch galvanized steel telephone conduit through the levee, 5.0 feet below the crown. (1.5-inch conduit authorized under Permit No. 12149, 1977 - Continental Telephone Company of California). Line originates at pole on landside (LS) shoulder. [Additional Reference(s): DWR Levee Log, 2006, (HLM 0.14)]. FS Date: 9/30/2019

Conduit enters levee LS slope at the pole

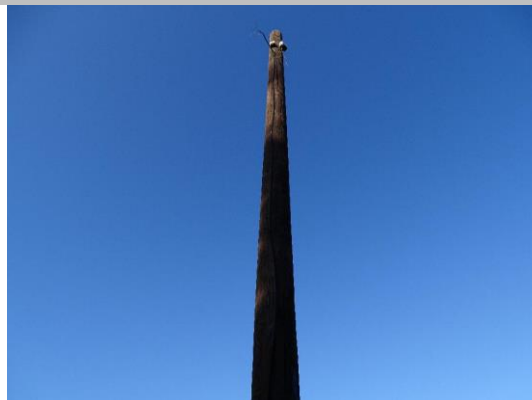
Photo 2 of 3 : UCIP_SP_2020_55790_82902.jpg

Disconnected cable on top of the pole

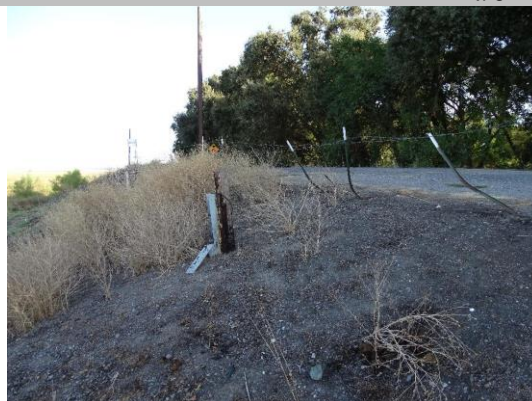
Photo 3 of 3 : UCIP_SP_2020_55790_82903.jpg

Abandoned telephone connection box on LS slope

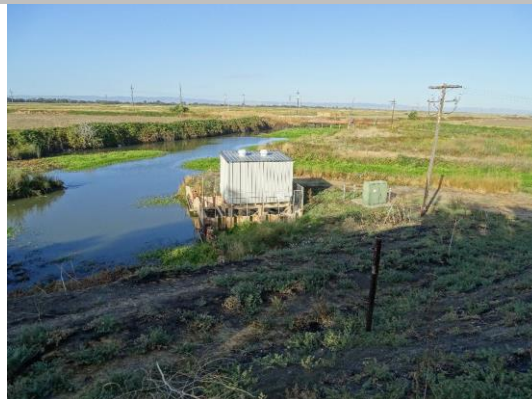
Photo 2 of 3 : UCIP_SP_2020_55791_82909.jpg

DS_ID:20224
 FS_ID:55791
 EP_NO: N/A
 Repair Type: Urgent
 Crossing Status: Found
 UCIP Comments: 9/30/2019 Record updated from Non-Urgent to Urgent. Erosion around headwall on WS progresses. Roger Cornwell who is a head of an irrigation district that operates the plant has been notified. Needs to run pumps to see if erosion is caused by leaking pipe(s). No permit has been identified authorizing pipe. (O.Yakimov - DWR UCIP)
 03/12/2013 Headwall on WS undermined about 3-4-feet. (W. Wylie - DWR UCIP)
 FIELD_STRUCT_DESC: 1 of 3: 36-inch steel drainage pipe through the levee, 30.0 feet below the crown. Flap gate on the waterside (WS) end. 24-inch pipe sleeved through the 36-inch pipe. Annular space between pipes grouted. Pumps in pump house with walkway on landside (LS) toe. [Additional Reference(s): DWR Levee Log, 2006, (HLM 0.15). USACE Sacramento O&M Manual 130, May 1960 (HLM 0.15), listed as three 36-inch pipes with gate on landside].

View of LS looking from levee crown

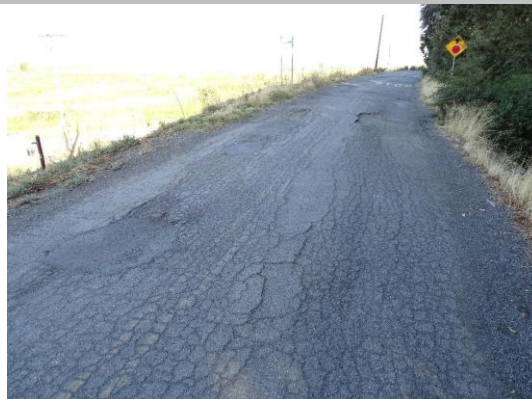
Photo 1 of 3 : UCIP_SP_2020_55792_82912.jpg

Comment Code						
Inspector Comment						
DS_ID:20356 FS_ID:55792 EP_NO: N/A Repair Type: Urgent Crossing Status: Found UCIP Comments: 9/30/2019 Record updated from Non-Urgent to Urgent. Erosion around headwall on WS progresses. Roger Cornwell who is a head of an irrigation district that operates the plant has been notified. Needs to run pumps to see if erosion is caused by leaking pipe(s). No permit has been identified authorizing pipe. (O.Yakimov - DWR UCIP) 03/12/2013 Headwall undermined 3-4-feet on WS toe. (W.Wylie - DWR UCIP) FIELD_STRUCT_DESC: 2 of 3: 36-inch steel drainage pipe through the levee, 30 feet below the crown. Flap gate on the waterside (WS) end. 24-inch pipe sleeved through the 36-inch pipe. Annular space between pipes grouted. Pumps inside pump house with a walkway on the landside (LS) toe. [Additional Reference(s): DWR Levee Log, 2006, (HLM 0.15). USACE Sacramento O&M Manual 130, May 1960 (HLM 0.15), listed as 36-inch pipes with gate on landside]. FS Date: 9/30/2019 8:01:37 AM

View of levee crown at the crossing

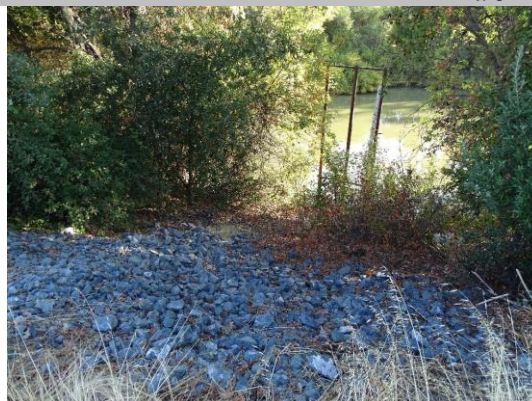
Photo 3 of 3 : UCIP_SP_2020_55792_82916.jpg

WS levee slope and air vents

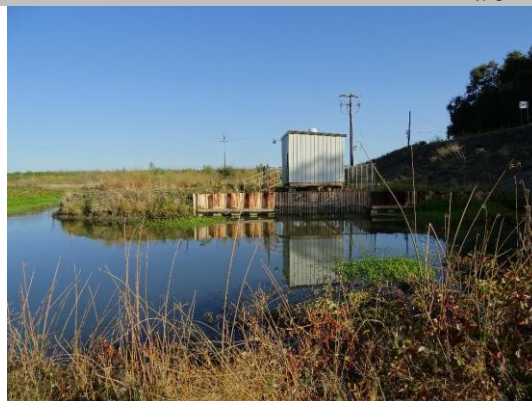
Photo 1 of 3 : UCIP_SP_2020_55793_82917.jpg

DS_ID:20357
 FS_ID:55793
 EP_NO: N/A
 Repair Type: Urgent
 Crossing Status: Found
 UCIP Comments: 9/30/2019 Record updated from Non-Urgent to Urgent. Erosion around headwall on WS progresses. Roger Cornwell who is a head of an irrigation district that operates the plant has been notified. Needs to run pumps to see if erosion is caused by leaking pipe(s). No permit has been identified authorizing pipe. (O.Yakimov - DWR UCIP)
 03/12/2013 Headwall undermined 3-4-feet on WS toe. (W.Wylie - DWR UCIP)
 FIELD_STRUCT_DESC: 3 of 3: 36-inch steel drainage pipe through the levee, 30 feet below the crown. Flap gate on the waterside (WS) end. 24-inch pipe sleeved through the 36-inch pipe. Annular space between pipes grouted. Pumps inside pump house with a walkway on the landside (LS) toe. [Additional Reference(s): DWR Levee Log, 2006, (HLM 0.15). USACE Sacramento O&M Manual 130, May 1960 (HLM 0.15), listed as 36-inch pipes with gate on landside].

Pump house on LS

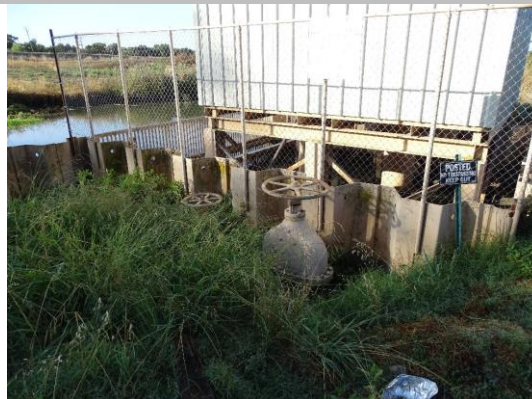
Photo 2 of 3 : UCIP_SP_2020_55793_82920.jpg

Slide gates at pumphouse on LS toe

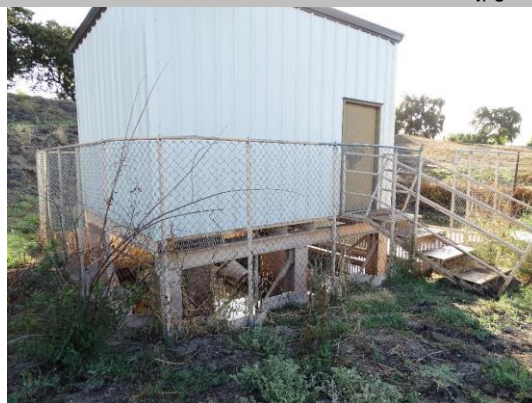
Photo 3 of 3 : UCIP_SP_2020_55793_82921.jpg

Pump house view from LS looking towards levee

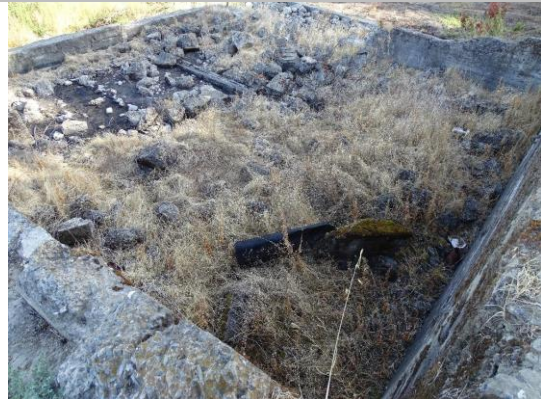
Photo 1 of 2 : UCIP_SP_2020_55794_82922.jpg

Comment Code					
Inspector Comment					
DS_ID:20327					
FS_ID:55794					
EP_NO: N/A					
Repair Type: Non-Urgent					
Crossing Status: Found					
UCIP Comments: 9/30/2019 Record updated from No Action Needed to Non-Urgent. No permit has been identified authorizing pipe. Crossing looks abandoned (O.Yakimov - DWR UCIP)					
FIELD_STRUCT_DESC: *ABANDONED* 42-inch drainage pipe of an unknown material through the levee, 28.5 feet below the crown.					
Abandoned in place by plugging with concrete. Headwall on waterside (WS) toe. [Additional Reference(s): USACE Sacramento O&M Manual 130, May 1960 (HLM 0.22), listed as 42-inch pipe].					
FS Date: 9/30/2019 9:45:45 AM

Ruins of a structure on LS

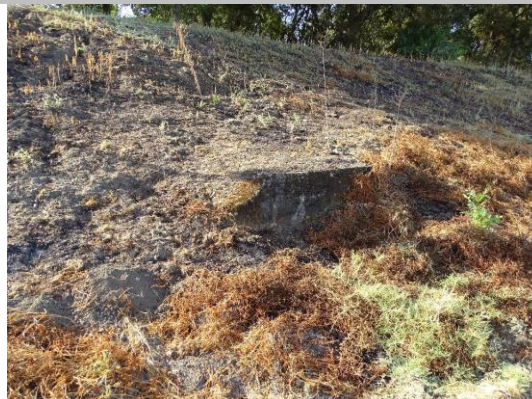
Photo 1 of 1 : UCIP_SP_2020_55795_82925.jpg

Comment Code						
Inspector Comment						
DS_ID:20328 FS_ID:55795 EP_NO: N/A Repair Type: Non-Urgent Crossing Status: Indicator Found UCIP Comments: 9/30/2019 Record updated from No Action Needed to Non-Urgent. No permit has been identified authorizing pipe. Top of concrete headwall visible on LS slope. Crossing looks abandoned (O.Yakimov - DWR UCIP) FIELD_STRUCT_DESC: *ABANDONED* 6-inch pipe of an unknown type and material through the levee, 10.3 feet below the crown. Abandoned by plugging with concrete. [Additional Reference(s): USACE Sacramento O&M Manual 130, May 1960 (HLM 0.23), 6-inch listed as abandoned and plugged]. FS Date: 9/30/2019

Concrete headwall on LS slope

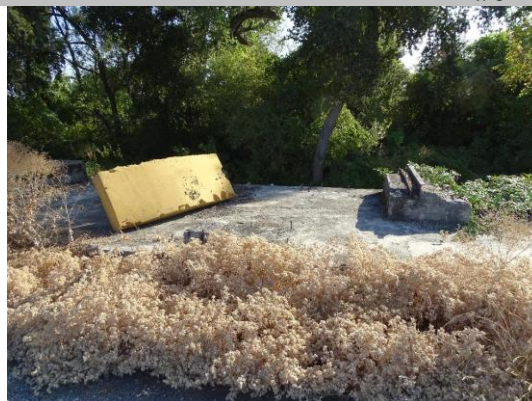
Photo 1 of 3 : UCIP_SP_2020_55797_82926.jpg

DS_ID:20225
FS_ID:55797
EP_NO: N/A
Repair Type: Non-Urgent
Crossing Status: Indicator Found
UCIP Comments: 9/30/2019 Record updated from No Action Needed to Non-Urgent. Abandoned concrete bulkhead on WS shoulder visible. Geophysical study indicates possible presence of pipe through levee. No permit has been identified authorizing pipe. (O.Yakimov - DWR UCIP)
FIELD_STRUCT_DESC: *ABANDONED* 1 of 3: 36-inch steel irrigation pipe through the levee, 18.3 feet below the crown. Steel plates bolted on the crown. Steel plates bolted on the waterside (WS) end. Pipes plugged with concrete. Concrete bulkhead on the WS slope. [Additional Reference(s): DWR Levee Log, 2006, (HLM 0.32). USACE Sacramento O&M Manual 130, May 1960 (HLM 0.32), listed as three 36-inch pipes plugged with concrete].
FS Date: 9/30/2019 10:10:23 AM

View of WS looking from levee crown

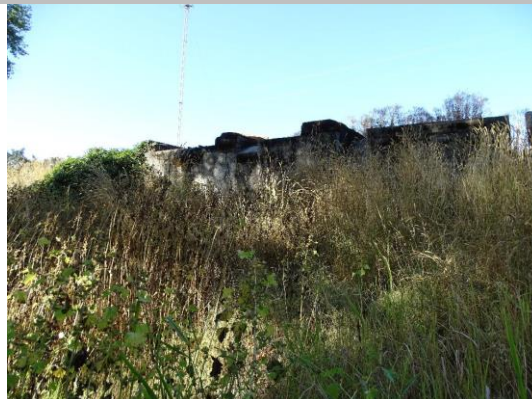
Photo 3 of 3 : UCIP_SP_2020_55799_82934.jpg

DS_ID:20359
FS_ID:55799
EP_NO: N/A
Repair Type: Non-Urgent
Crossing Status: Indicator Found
UCIP Comments: 9/30/2019 Record updated from No Action Needed to Non-Urgent. Geophysical study indicates possible presence of pipe through levee. No permit has been identified authorizing pipe. Abandoned concrete bulkhead on WS shoulder visible. (O.Yakimov - DWR UCIP)
FIELD_STRUCT_DESC: *ABANDONED* 3 of 3: 36-inch steel irrigation pipe through the levee, 18.3 feet below the crown. Steel plates bolted on the crown. Steel plates bolted on the waterside (WS) end. Pipes plugged with concrete. Concrete bulkhead on the WS slope. [Additional Reference(s): DWR Levee Log, 2006, (HLM 0.32). USACE Sacramento O&M Manual 130, May 1960 (HLM 0.32), listed as three 36-inch pipes plugged with concrete].
FS Date: 9/30/2019 10:17:27 AM

Concrete bulkhead on the WS slope

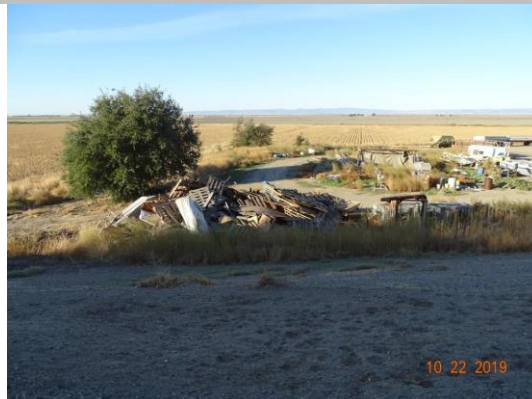
Photo 1 of 1 : SP_2020_NA0016_435_1550_20200228_00061.jpg

LM Start	2.40	Rating **	M	Issue No.	1550
LM End	2.40	Issue Type +	En	Location *	LS
Category	Earthen Levee			GPS Latitude/Longitude	
				Start	End
Item	Encroachments			38.832295 °	38.832295 °
				-121.729408 °	-121.729408 °
DWR ID	DWR_NA0016_01_f _ 2013_1550				
Comment Code					
EQ : Equipment					
Inspector Comment					
Equipment is located at the levee toe.

View of equipment and debris at the landside toe. Fall 2019.

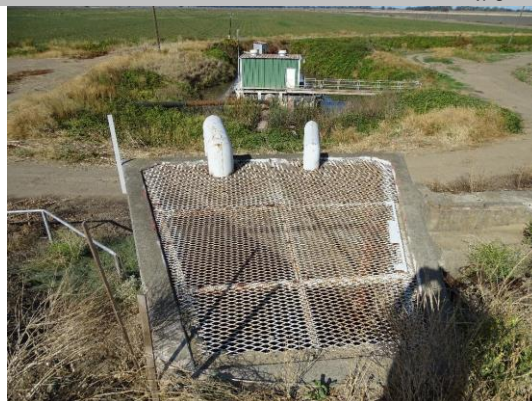
Photo 2 of 3 : UCIP_SP_2020_55802_82944.jpg

Comment Code						
Inspector Comment						
DS_ID:20331 FS_ID:55802 EP_NO: N/A Repair Type: Non-Urgent Crossing Status: Found UCIP Comments: 9/30/2019 Record updated from No Action Needed to Non-Urgent. No permit has been identified authorizing pipe. (O.Yakimov - DWR UCIP) FIELD_STRUCT_DESC: 5-foot by 5-foot reinforced concrete box drainage tunnel through the levee, 33 feet below the crown. Slide gate at outlet on the waterside (WS) toe. Tunnel runs from concrete U-shaped riser unit on the landside (LS) shoulder to the WS toe. Steel walkway to slide gate actuator on the WS berm. [Additional Reference(s): USACE Sacramento O&M Manual 130, May 1960 (HLM 3.59), listed as 5'x5' concrete tunnel with gate on landside]. FS Date: 9/30/2019 12:53:17 PM

Top of concrete distribution box. Two filling pipes are coming from pump house.

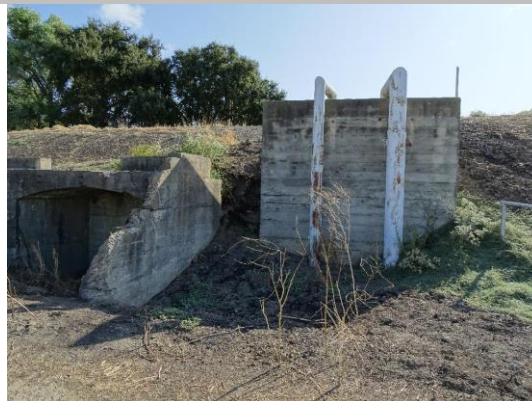
Photo 3 of 3 : UCIP_SP_2020_55802_82943.jpg

Concrete distribution box on LS slope

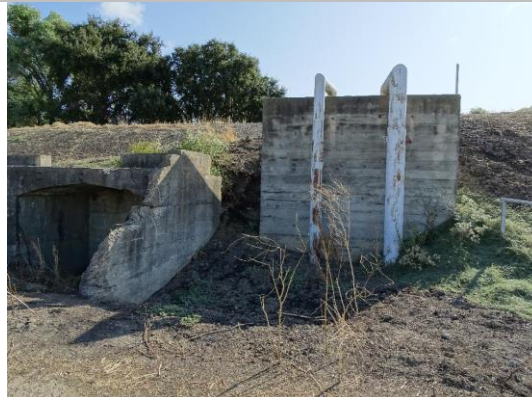
Photo 1 of 2 : UCIP_SP_2020_55804_82946.jpg

DS_ID:20227
 FS_ID:55804
 EP_NO: 1684
 Repair Type: Non-Urgent
 Crossing Status: Indicator Found
 UCIP Comments: 9/30/2019 Record updated from No Action Needed to Non-Urgent. Unable to find an indicator of pipe. Concrete distribution box is covered with metal grating sheet not letting look down inside the box. (O.Yakimov - DWR UCIP)
 FIELD_STRUCT_DESC: 44-inch steel storm drainage pipe through the levee, 25 feet below the crown. Slide gate on both ends. Siphon breaker on the waterside (WS). Two concrete cutoff walls. Metal walkway to slide gate on the WS. (44-inch concrete jacketed pipe connected to existing 60-inch outlet conduit authorized under Permit No. 1684, 1952 - River Farms Company of California). Pipe discharges into 5-foot by 5-foot concrete tunnel. [Additional Reference(s): DWR Levee Log, 2006, (HLM 3.59). USACE Sacramento O&M Manual 130, May 1960, (HLM 3.59), listed as a 42-inch pipe with gate on landside and bolted steel plate one end, 14.5 feet below the crown].

Concrete distribution box at LS toe

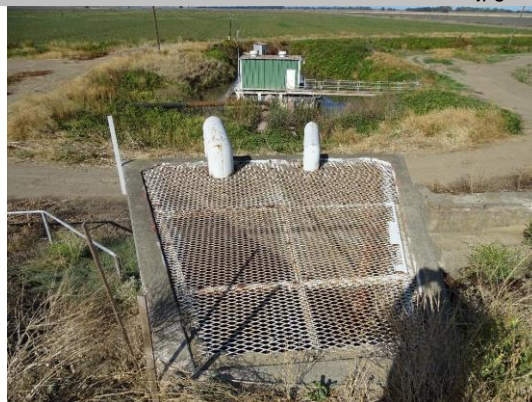
Photo 2 of 2 : UCIP_SP_2020_55804_82947.jpg

44-inch pipe discharges into 5' x 5' concrete tunnel at the bottom of this box

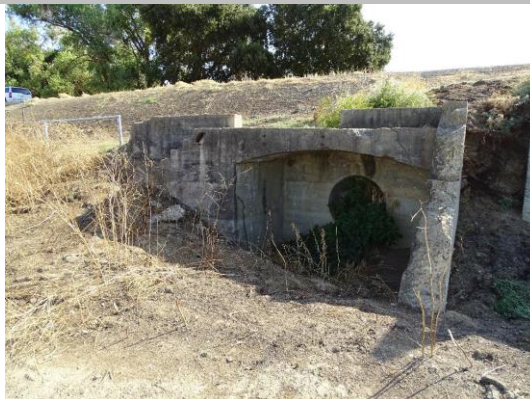
Photo 2 of 3 : UCIP_SP_2020_55806_82950.jpg

Disrupted structure with a channel where headwall and pipe observed

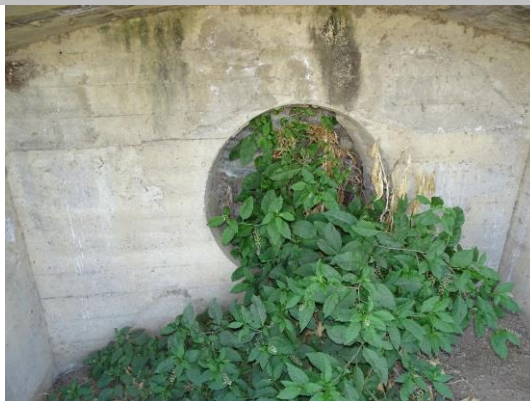
Photo 3 of 3 : UCIP_SP_2020_55806_82948.jpg

Pipe and headwall on LS

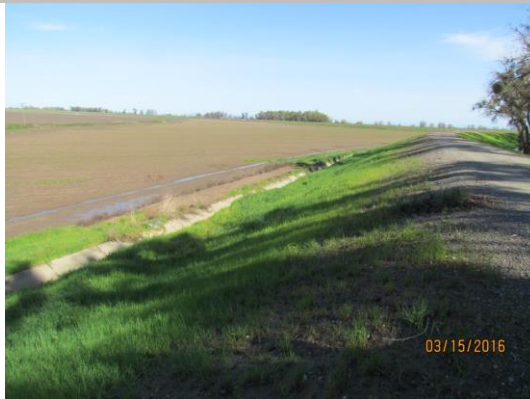
Photo 1 of 1 : SP_2020_NA0016_435_8_20200228_00001.jpg

LM Start	3.56	Rating **	M	Issue No.	8
LM End	3.94	Issue Type +	En	Location *	LS
Category	Earthen Levee			GPS Latitude/Longitude	
				Start	End
Item	Encroachments			38.846785 °	38.850758 °
				-121.729995 °	-121.725263 °
DWR ID	DWR_NA0016_01_s_2012_8				
Comment Code					
DT : Ditch					
Inspector Comment					
Concrete lined ditch runs along the levee toe.

View of the ditch on the landward side of the levee looking upstream.
Spring 2016.

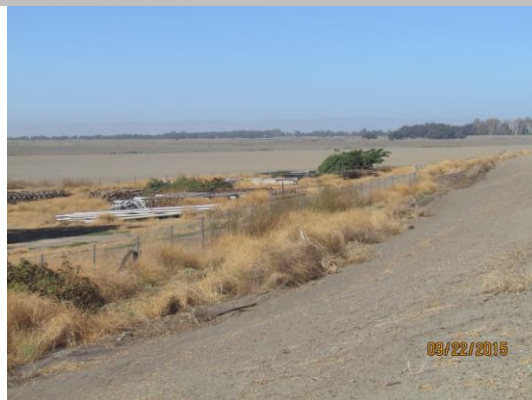
Photo 1 of 1 : SP_2020_NA0016_435_9_20200228_00002.jpg

LM Start	4.80	Rating **	M	Issue No.	9
LM End	4.91	Issue Type +	En	Location *	LS
Category	Earthen Levee			GPS Latitude/Longitude	
				Start	End
Item	Encroachments			38.859446 °	38.859684 °
				-121.732774 °	-121.734767 °
DWR ID	DWR_NA0016_01_s_2012_9				
Comment Code					
FE : Fence					
Inspector Comment					
A chain link fence runs along levee toe.

View of the chain link fence along the landward levee toe looking upstream. The fence does not obstruct the view. Fall 2015.

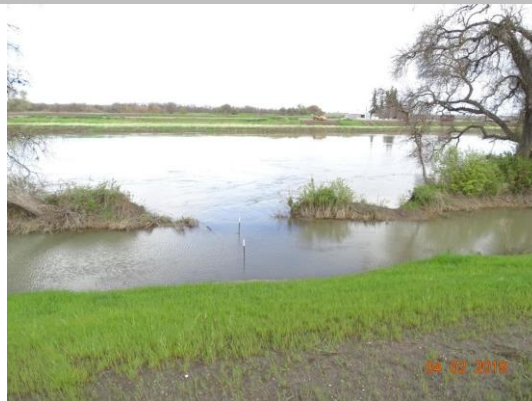
Photo 1 of 4 : SP_2020_NA0016_435_112_20200228_00038.jpg

LM Start	8.55	Rating **	A/W	Issue No.	112
LM End	8.55	Issue Type +	Ma	Location *	WS
Category	Earthen Levee			GPS Latitude/Longitude	
				Start	End
Item	Erosion / Bank Caving			38.857422 °	38.857422 °
				-121.780870 °	-121.780870 °
DWR ID	DWR_NA0016_01_s_2018_112				
Comment Code					
E1 : Note and monitor erosion site.					
Inspector Comment					
Location on waterside berm where oak tree fell and removed soil around the roots. Appears to be stable, but recommend monitoring.

View of erosion on the waterside berm. Spring 2019.

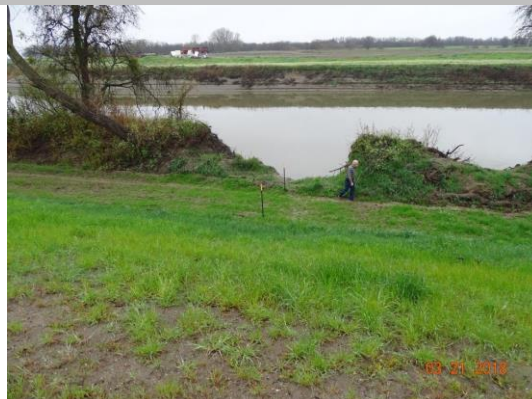
Photo 2 of 4 : SP_2020_NA0016_435_112_20200228_00039.jpg

View of the berm where the oak tree used to stand, facing the Sacramento River. Spring 2018.

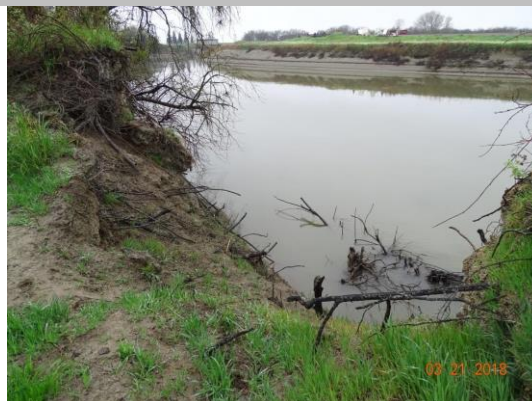
Photo 3 of 4 : SP_2020_NA0016_435_112_20200228_00040.jpg

View of the remaining roots, facing upstream. Spring 2018.

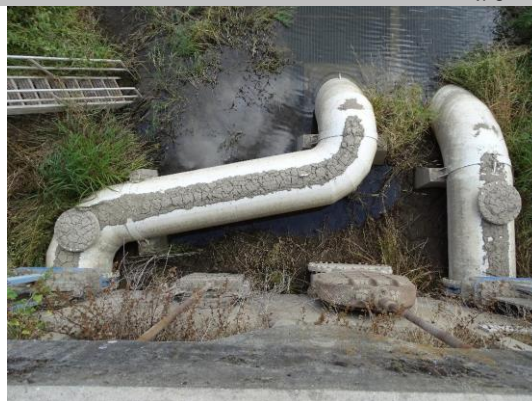
Photo 1 of 3 : UCIP_SP_2020_55837_83095.jpg

DS_ID:20230
FS_ID:55837
EP_NO: 9376
Repair Type: Non-Urgent
Crossing Status: Found
UCIP Comments: 9/30/2019 Record updated from No Action Needed to Non-Urgent. Need to have CVFPB review ABO and determine current owner. (O.Yakimov - DWR UCIP)
FIELD_STRUCT_DESC: [El Dorado Bend Pumping Plant] 1 of 4: 50-inch sleeved through existing 54-inch concrete encased steel drainage pipe through the levee, 26.5 feet below the crown. Gate valves on the waterside (WS) ends of the pipes. Walkway provided to the control valves and around the pump house on the landside (LS). Pipes originate in a large concrete pool at the pump house on the LS. (Four 54-inch pipe [HLM 5.27] authorized under Automatic Board Order (ABO) issued as Permit No. 9376, 1974 - Reclamation District Nos. 2047 and 108; 50-inch pipe sleeved through existing 54-inch pipe and trash rack repairs authorized under maintenance in 2013). [Additional Reference(s): DWR Levee Log, 2006, (HLM 8.99). USACE Sacramento O&M Manual 130, May 1960 (HLM 8.99), listed as four 54-inch pipes with gates on landside].

Headwall, slide gate, pipe in river channel

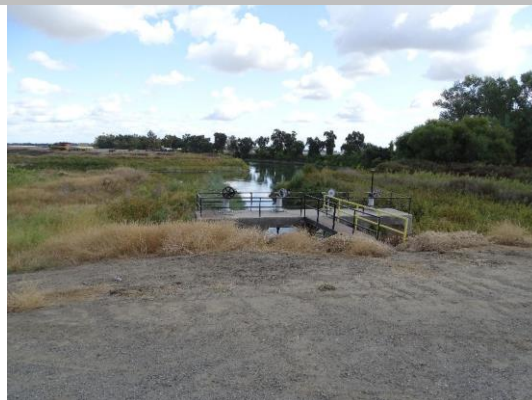
Photo 2 of 3 : UCIP_SP_2020_55837_83075.jpg

Walkway to slide gate actuators on WS shoulder

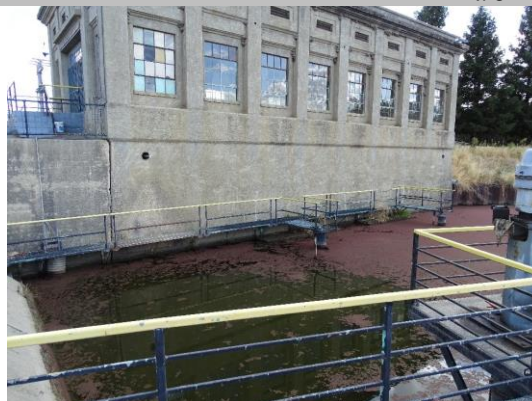
Photo 3 of 3 : UCIP_SP_2020_55837_83096.jpg

LM Start	8.89	Rating **	M	Issue No.	1566 (cont)
LM End	8.89	Issue Type +	Ma	Location *	
Category	Supplemental		GPS Latitude/Longitude		
			Start	End	
Item	DWR UCIP LMA Responsibility		38.856531 °	38.856531 °	
			-121.785605 °	-121.785605 °	
DWR ID	20230

LS view of pumping plant looking from irrigation canal

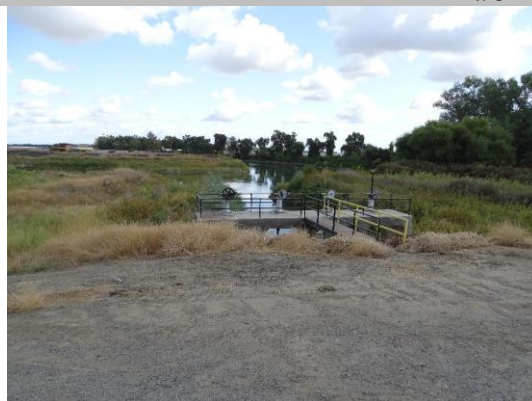
Photo 1 of 3 : UCIP_SP_2020_55838_83077.jpg

DS_ID:20361
FS_ID:55838
EP_NO: 9376
Repair Type: Non-Urgent
Crossing Status: Found
UCIP Comments: 9/30/2019 Record updated from No Action Needed to Non-Urgent. Need to have CVFPB review ABO and determine current owner. (O.Yakimov - DWR UCIP)
FIELD_STRUCT_DESC: [El Dorado Bend Pumping Plant] 2 of 4: 54-inch concrete encased steel drainage discharge pipe through the levee, 26.5 feet below the crown. Gate valves on both ends of the pipe. Walkway provided to the gate valves on the waterside (WS) shoulder. Pipe not visible on landside (LS) toe. (Four 54-inch pipe [HLM 5.27] authorized under Automatic Board Order (ABO) issued as Permit No. 9376, 1974 - Reclamation District Nos. 2047 and 108; now work was done in 2013 at this location). [Additional Reference(s): DWR Levee Log, 2006, (HLM 8.99). USACE Sacramento O&M Manual 130, May 1960 (HLM 8.99), listed as four 54-inch pipes with gate on landside].
FS Date: 9/30/2019 11:11:30 AM

Walkway to slide gate actuators on WS shoulder

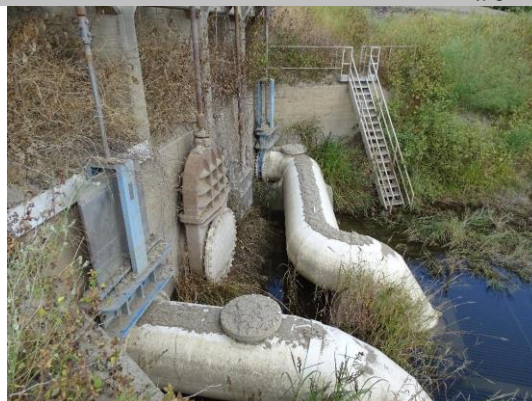
Photo 2 of 3 : UCIP_SP_2020_55838_83078.jpg

Pipes and slide gates at outlet onWS

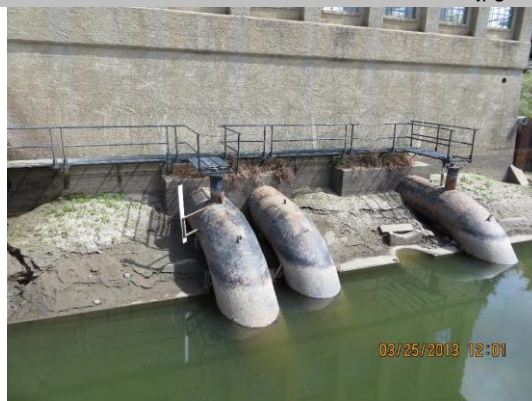
Photo 3 of 3 : UCIP_SP_2020_55838_17317.jpg

Pipe missing from intake structure on LS of pump house.

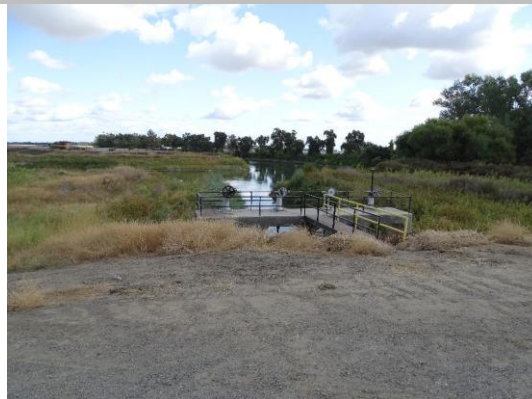
Photo 1 of 3 : UCIP_SP_2020_55839_83079.jpg

DS_ID:20362
FS_ID:55839
EP_NO: 9376
Repair Type: Non-Urgent
Crossing Status: Found
UCIP Comments: 9/30/2019 Record updated from No Action Needed to Non-Urgent. Need to have CVFPB review ABO and determine current owner. (O.Yakimov - DWR UCIP)
FIELD_STRUCT_DESC: [El Dorado Bend Pumping Plant] 3 of 4: 50-inch sleeved through existing 54-inch concrete encased steel drainage discharge pipe through the levee, 26.5 feet below the crown. Gate valves on both ends of the pipe. Walkway provided to the control valves inside the pump house. (Four 54-inch pipes [HLM 5.27] authorized under Automatic Board Order (ABO) issued as Permit No. 9376, 1974 - Reclamation District Nos. 2047 and 108; 50-inch pipe sleeved through existing 54-inch pipe and trash rack repairs authorized under maintenance in 2013). [Additional Reference(s): DWR Levee Log, 2006, (HLM 8.99). USACE Sacramento O&M Manual 130, May 1960 (HLM 8.99), listed as four 54-inch pipes with gate on landside].

Slide gate actuators on platform at WS shoulder

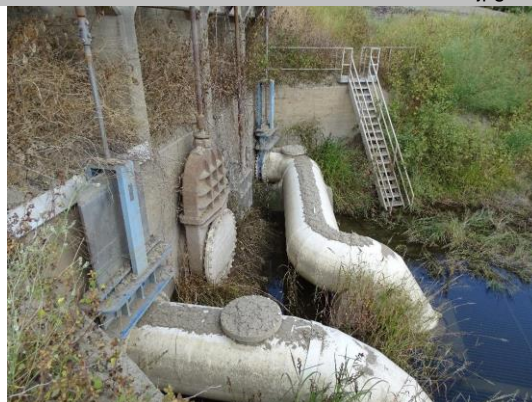
Photo 2 of 3 : UCIP_SP_2020_55839_83080.jpg

Pipes and slide gates at outlet on WS

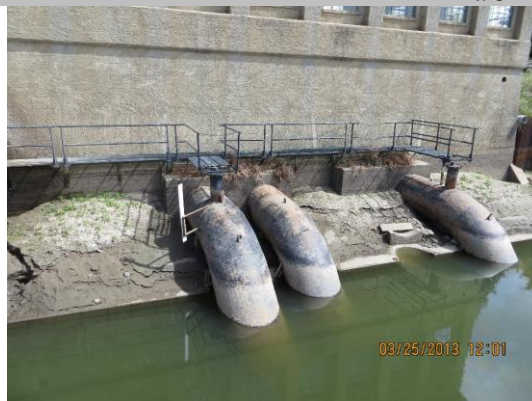
Photo 3 of 3 : UCIP_SP_2020_55839_17321.jpg

Pipes at inlet on LS of pumphouse.

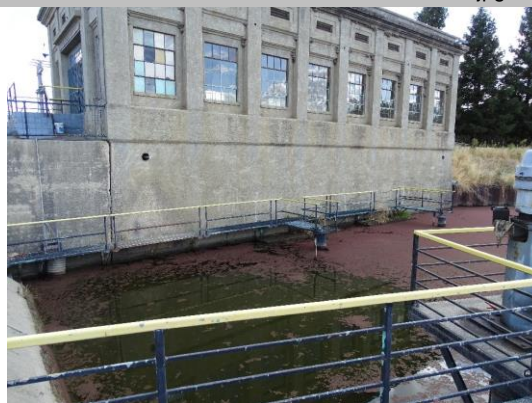
Photo 3 of 3 : UCIP_SP_2020_55836_83074.jpg

DS_ID:20363
FS_ID:55836
EP_NO: 9376
Repair Type: Non-Urgent
Crossing Status: Found
UCIP Comments: 9/30/2019 Record updated from No Action Needed to Non-Urgent. Need to have CVFPB review ABO and determine current owner. Pipe outlet on WS has been modified to serve at inlet. Pipe runs down to a sump in river channel. (O.Yakimov - DWR UCIP)
FIELD_STRUCT_DESC: [El Dorado Bend Pumping Plant] 4 of 4: 50-inch sleeved through existing 54-inch concrete encased steel drainage discharge pipe through the levee, 26.5 feet below the crown. Gate valves on both ends of the pipe. Walkway provided to the control valves. (Four 54-inch pipes [HLM 5.27] authorized under Automatic Board Order (ABO) issued as Permit No. 9376, 1974 - Reclamation District Nos. 2047 and 108; 50-inch pipe sleeved through existing 54-inch pipe and trash rack repairs authorized under maintenance in 2013). [Additional Reference(s): DWR Levee Log, 2006, (HLM 8.99). USACE Sacramento O&M Manual 130, May 1960 (HLM 8.99), listed as four 54-inch pipes with gate on landside].

LS view of pumping plant looking from irrigation canal

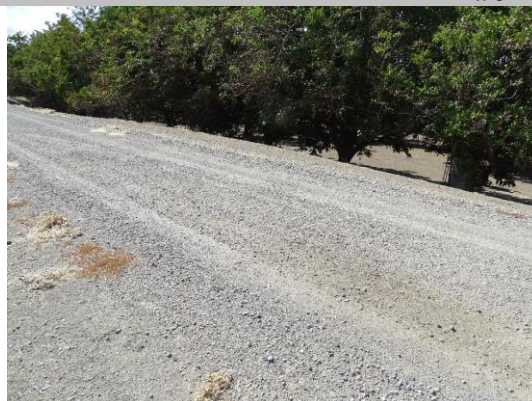
Photo 1 of 3 : UCIP_SP_2020_55840_83081.jpg

Comment Code						
Inspector Comment						
DS_ID:20231 FS_ID:55840 EP_NO: 1641 Repair Type: Non-Urgent Crossing Status: Found UCIP Comments: 09/30/2019 Pipe is exposed on both levee slopes. Opening in the pipe left after water meter removal has been welded. Crossing remains Non-Urgent, depression along pipe alignment under pump platform about 10 feet off WS levee toe needs further observation. (O.Yakimov - DWR UCIP)09/23/2016 - pipe is not actively used. No power to pump platform. vegetation growth obscuring view along pipe alignment on the WS toe (T.Hatch/UCIP) 09/01/2016 pipe is visible on the WS slope of the levee. The pipe appears intact on the WS and does not appear to have a meter. The siphon breaker on the LS slope appears to have been removed and replaced by a cap. No holes or missing connections were visible. WS levee slope appears to have a slight depression in the vicinity of the exposed pipe. (T. Hatch/UCIP) 03/13/2013 - Meter removed from the pipe on the WS and pipe is open. Pipe appears abandoned, and, if so, should be abandoned properly. (W. Wylie/UCIP) FIELD_STRUCT_DESC: *ABANDONED* 14-inch steel irrigation pipe through the levee, 5.2 feet below the crown. Slant pump on a concrete pump platform on the waterside (WS). Siphon breaker on the landside (LS) slope. Sparling flow meter on the pipe on the WS slope. 42-inch concrete standpipe in a concrete distribution box at the landside (LS) toe. (14-inch pipe authorized under permit No. 1641, 1952 - William Erdman Jr.). [Additional Reference(s): DWR Levee Log, 2006, HLM 9.31. USACE Sacramento O&M Manual 130, May 1960 (HLM 9.31), listed as 14-inch pipe]. FS Date: 9/30/2019 11:16:09 AM

View of levee crown at the crossing

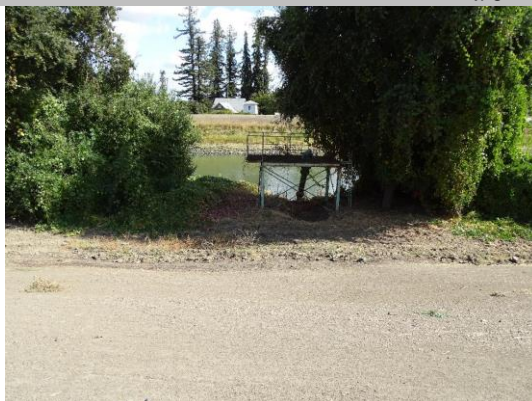
Photo 2 of 3 : UCIP_SP_2020_55840_83082.jpg

View of WS looking from levee crown

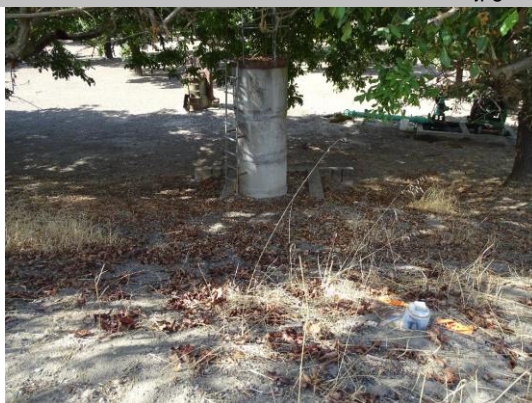
Photo 3 of 3 : UCIP_SP_2020_55840_83083.jpg

Concrete riser on LS toe

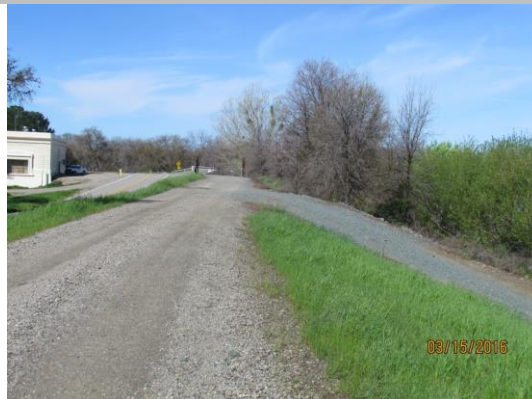
Photo 1 of 2 : SP_2020_NA0016_435_29_20200228_00006.jpg

LM Start	9.68	Rating **	A/W	Issue No.	29
LM End	9.79	Issue Type +	Ma	Location *	WS
Category	Earthen Levee			GPS Latitude/Longitude	
				Start	End
Item	Vegetation			38.862345 °	38.862848 °
				-121.791337 °	-121.793267 °
DWR ID	DWR_NA0016_01_s_2012_29				
Comment Code					
V8 : Environmental Requirements.					
Inspector Comment

View of the revegetation site on the waterward side of the levee looking upstream. Spring 2016.

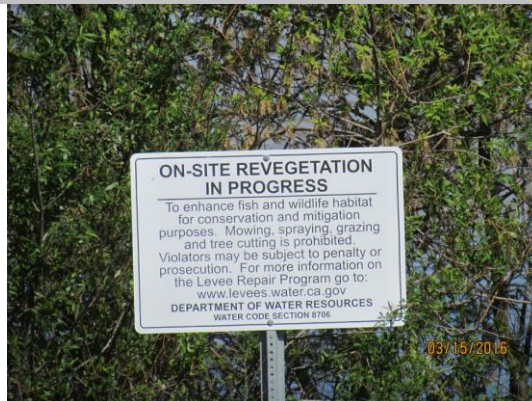
Photo 2 of 2 : SP_2020_NA0016_435_29_20200228_00007.jpg

Revegetation site sign. Spring 2016.

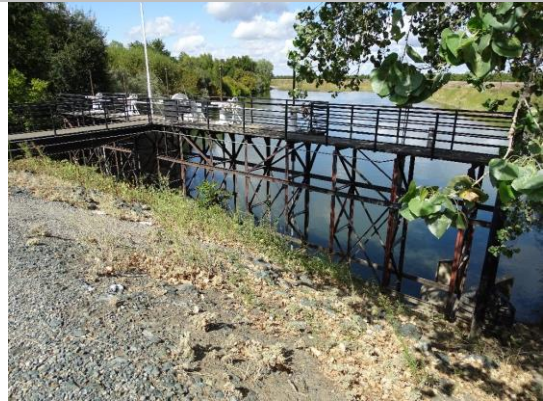
Photo 1 of 3 : UCIP_SP_2020_55842_83088.jpg

Comment Code						
Inspector Comment						
DS_ID:20232 FS_ID:55842 EP_NO: N/A Repair Type: Non-Urgent Crossing Status: Found UCIP Comments: 9/30/2019 Record updated from No Action Needed to Non-Urgent. Need to have CVFPB review ABO and determine current owner. (O.Yakimov - DWR UCIP) FIELD_STRUCT_DESC: [Rough & Ready Pumping Plant] 1 of 5: 60-inch reinforced concrete drainage culvert through the levee, 35 feet below the crown. Screw gates on walkway at waterside (WS) shoulder. Staff gauge to 47.0 feet on structure. [Additional Reference(s): DWR Levee Log, 2006, (HLM 9.87). USACE Sacramento O&M Manual 130, May 1960 (HLM 9.87), five 60-inch pipes with gates on waterside]. FS Date: 9/30/2019 11:47:04 AM

Slide gate actuators on WS shoulder

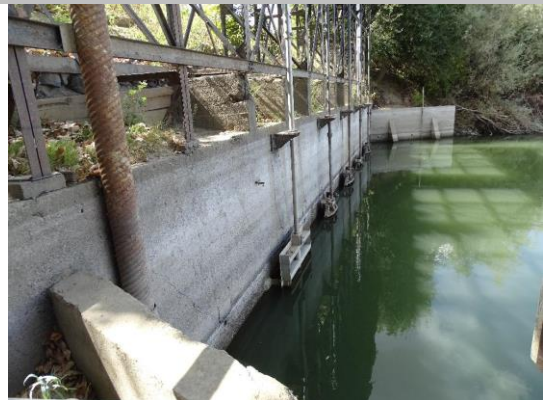
Photo 2 of 3 : UCIP_SP_2020_55842_83097.jpg

Slide gates at concrete headwall at river

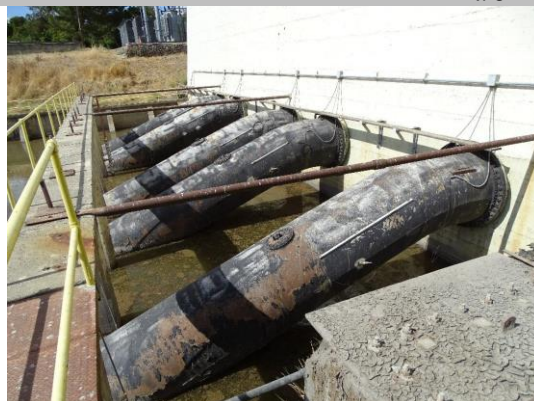
Photo 3 of 3 : UCIP_SP_2020_55842_83098.jpg

Pipes at entrance to pumping plant building on LS toe

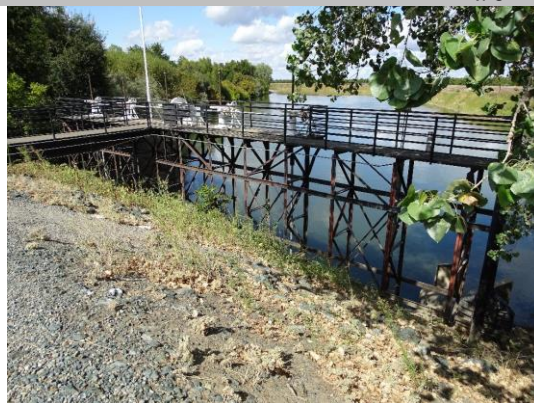
Photo 1 of 3 : UCIP_SP_2020_55843_83099.jpg

DS_ID:20364
 FS_ID:55843
 EP_NO: N/A
 Repair Type: Non-Urgent
 Crossing Status: Found
 UCIP Comments: 9/30/2019 Record updated from No Action Needed to Non-Urgent. Need to have CVFPB review ABO and determine current owner. (O.Yakimov - DWR UCIP)
 FIELD_STRUCT_DESC: [Rough & Ready Pumping Plant] 2 of 5: 60-inch reinforced concrete drainage culvert through the levee, 35 feet below the crown. Screw gate actuators on metal platform on the waterside (WS) shoulder. Large pumping plant building on the landside (LS) shoulder. Staff gauge to 47 feet on structure. [Additional Reference(s): DWR Levee Log, 2006, (HLM 9.87). USACE Sacramento O&M Manual 130, May 1960 (HLM 9.87), five 60-inch pipes with gates on waterside].
 FS Date: 9/30/2019 11:47:39 AM

Slide gate actuators on WS shoulder

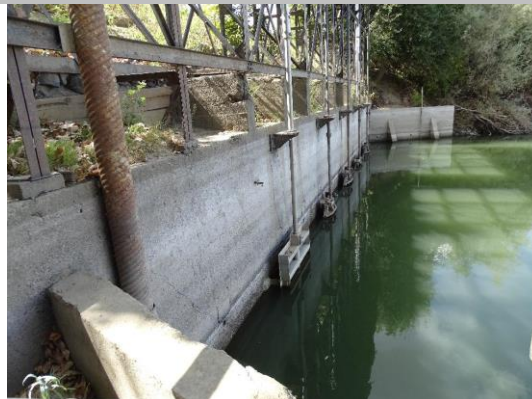
Photo 2 of 3 : UCIP_SP_2020_55843_83100.jpg

Slide gates at concrete headwall at river

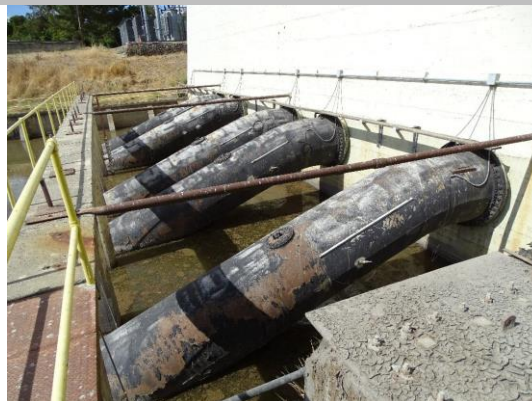
Photo 3 of 3 : UCIP_SP_2020_55843_83101.jpg

Pipes at entrance to pumping plant building on LS toe

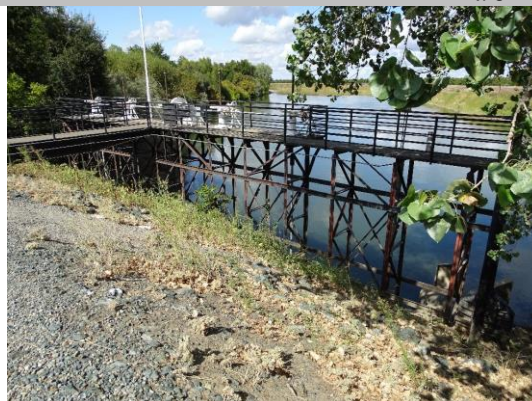
Photo 1 of 3 : UCIP_SP_2020_55844_83102.jpg

Comment Code						
Inspector Comment						
DS_ID:20365 FS_ID:55844 EP_NO: N/A Repair Type: Non-Urgent Crossing Status: Found UCIP Comments: 9/30/2019 Record updated from No Action Needed to Non-Urgent. Need to have CVFPB review ABO and determine current owner. (O.Yakimov - DWR UCIP) FIELD_STRUCT_DESC: [Rough & Ready Pumping Plant] 3 of 5: 60-inch reinforced concrete drainage culvert through the levee, 35 feet below the crown. Screw gate actuators on metal platform on the waterside (WS) shoulder. Large pumping plant building on the landside (LS) shoulder. Staff gauge to 47 feet on structure. [Additional Reference(s): DWR Levee Log, 2006, (HLM 9.87). USACE Sacramento O&M Manual 130, May 1960 (HLM 9.87), five 60-inch pipes with gates on waterside]. FS Date: 9/30/2019 11:48:05 AM

Slide gate actuators on WS shoulder

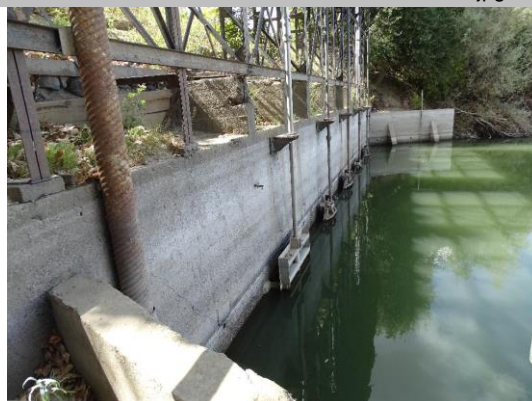
Photo 2 of 3 : UCIP_SP_2020_55844_83103.jpg

Slide gates at concrete headwall at river

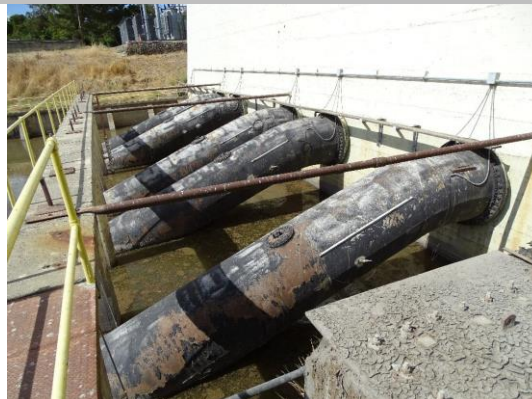
Photo 3 of 3 : UCIP_SP_2020_55844_83104.jpg

Pipes at entrance to pumping plant building on LS toe

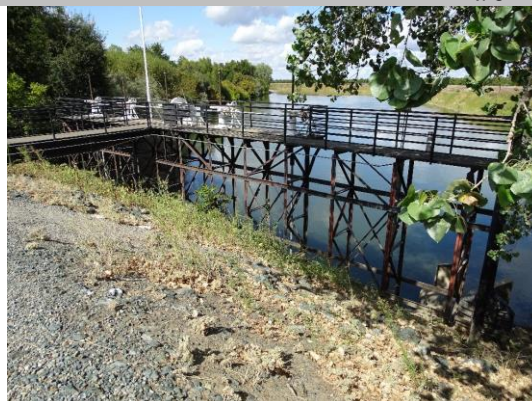
Photo 1 of 3 : UCIP_SP_2020_55845_83105.jpg

Slide gate actuators on WS shoulder

Comment Code					
Inspector Comment					
DS_ID:20366 FS_ID:55845 EP_NO: N/A Repair Type: Non-Urgent Crossing Status: Found UCIP Comments: 9/30/2019 Record updated from No Action Needed to Non-Urgent. Need to have CVFPB review ABO and determine current owner. (O.Yakimov - DWR UCIP) FIELD_STRUCT_DESC: [Rough & Ready Pumping Plant] 4 of 5: 60-inch reinforced concrete drainage culvert through the levee, 35 feet below the crown. Screw gate actuators on metal platform on the waterside (WS) shoulder. Large pumping plant building on the landside (LS) shoulder. Staff gauge to 47 feet on structure. [Additional Reference(s): DWR Levee Log, 2006, (HLM 9.87). USACE Sacramento O&M Manual 130, May 1960 (HLM 9.87), five 60-inch pipes with gates on waterside]. FS Date: 9/30/2019 11:48:29 AM

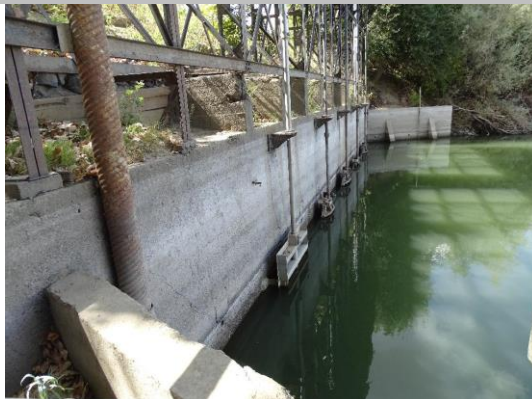
Photo 2 of 3 : UCIP_SP_2020_55845_83106.jpg

Slide gates at concrete headwall at river

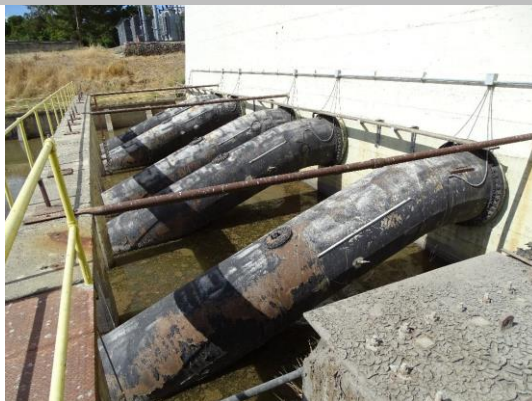
Photo 3 of 3 : UCIP_SP_2020_55845_83107.jpg

Pipes at entrance to pumping plant building on LS toe

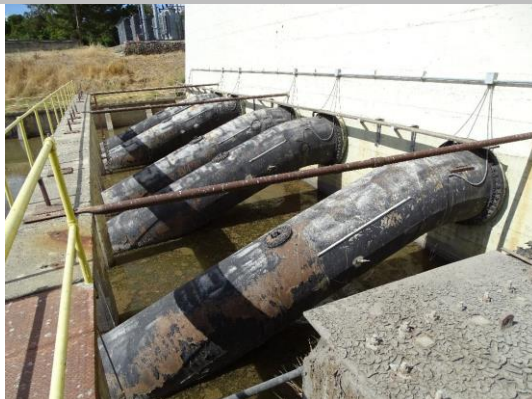
Photo 3 of 3 : UCIP_SP_2020_55846_83110.jpg

Comment Code						
Inspector Comment						
DS_ID:20367 FS_ID:55846 EP_NO: N/A Repair Type: Non-Urgent Crossing Status: Found UCIP Comments: 9/30/2019 Record updated from No Action Needed to Non-Urgent. Need to have CVFPB review ABO and determine current owner. (O.Yakimov - DWR UCIP) FIELD_STRUCT_DESC: [Rough & Ready Pumping Plant] 5 of 5: 60-inch reinforced concrete drainage culvert through the levee, 35 feet below the crown. Screw gate actuators on metal platform on the waterside (WS) shoulder. Large pumping plant building on the landside (LS) shoulder. Staff gauge to 47 feet on structure. [Additional Reference(s): DWR Levee Log, 2006, (HLM 9.87). USACE Sacramento O&M Manual 130, May 1960 (HLM 9.87), five 60-inch pipes with gates on waterside]. FS Date: 9/30/2019 11:48:54 AM

Pipes at entrance to pumping plant building on LS toe

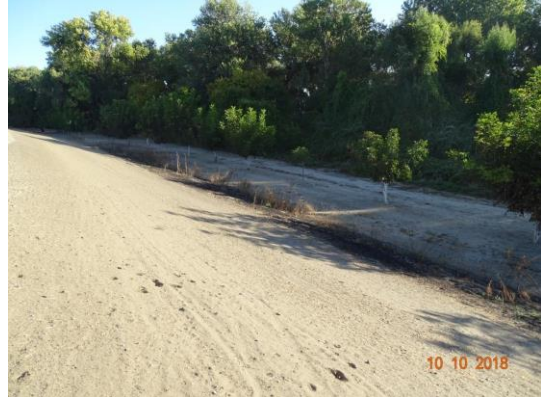
Photo 1 of 1 : SP_2020_NA0016_435_106_20200228_00035.jpg

LM Start	10.66	Rating **	M	Issue No.	106
LM End	10.80	Issue Type +	En	Location *	WS
Category	Earthen Levee			GPS Latitude/Longitude	
				Start	End
Item	Encroachments			38.866474 °	38.868426 °
				-121.803711 °	-121.803732 °
DWR ID	DWR_NA0016_01_f _ 2019_106				
Comment Code					
CR : Crops					
Inspector Comment					
A walnut orchard is located on the waterside berm.

View of walnut orchard on the waterside berm. Fall 2018.

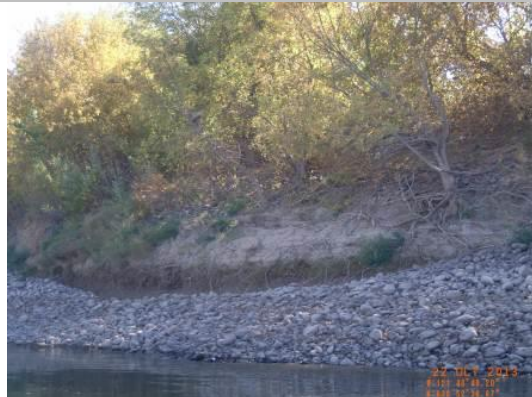
Photo 1 of 1 : SP_2020_NA0016_435_84_20200228_00018.jpg

LM Start	11.50	Rating **	A/W	Issue No.	84
LM End	11.53	Issue Type +	Ma	Location *	WS
Category	Supplemental			GPS Latitude/Longitude	
				Start	End
Item	2017 USACE Erosion Survey			38.874854 °	38.875109 °
				-121.813018 °	-121.813592 °
DWR ID	DWR_NA0016_01_f_2018_84				
Comment Code					
Inspector Comment					
2017 Site ID: SAC 101.3 R					
Status: Eroding					
2017 Field Notes: No observed change..					
Site History: 1997 - Toe damage and loss of cobble revetment and small patch of local damage to the cobble revetment. 2000 - Cohesive vertical toe; revegetation site.

USACE 2013 Photo #1

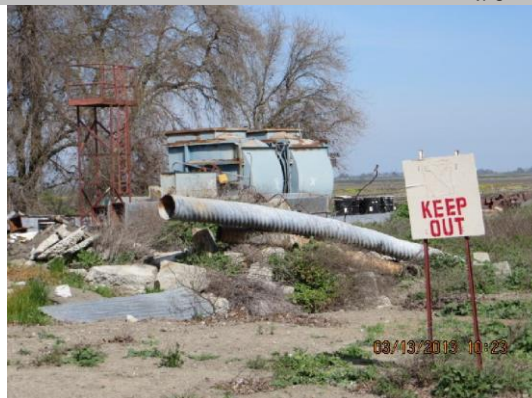
Photo 1 of 1 : UCIP_SP_2020_55856_17368.jpg

LM Start	12.24	Rating **	M	Issue No.	1576
LM End	12.24	Issue Type +	En	Location *	
Category	Supplemental			GPS Latitude/Longitude	
				Start	End
Item	DWR UCIP Field Study			38.883987 °	38.883987 °
				-121.817418 °	-121.817418 °
DWR ID	20233

Comment Code					
Inspector Comment					
DS_ID:20233					
FS_ID:55856					
EP_NO: N/A					
Repair Type: Non-Urgent					
Crossing Status: Not Found					
UCIP Comments: 9/30/2019 Record updated from No Action Needed to Non-Urgent. Geophysical study indicates possible presence of pipe through levee. Crossing not found. Unauthorized encroachment recorded in Levee Log prior to 2011. (O.Yakimov - DWR UCIP)					
FIELD_STRUCT_DESC: 9-inch corrugated metal drainage pipe through the levee, at an unknown depth. Installed prior to 1974. Pipe debris at LM 12.38 includes a 9-inch CMP. [Additional Reference(s): DWR Levee Log, 2006, (HLM 12.45)].					
FS Date: 9/30/2019 1:53:01 PM

Pipe debris on LS shoulder at LM 12.38 includes a 9-inch CMP.

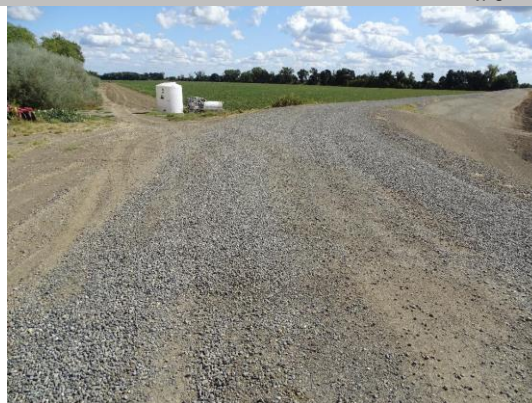
Photo 1 of 3 : UCIP_SP_2020_55858_83114.jpg

LM Start	14.09	Rating **	M	Issue No.	1577
LM End	14.09	Issue Type +	En	Location *	
Category	Supplemental			GPS Latitude/Longitude	
				Start	End
Item	DWR UCIP Field Study			38.906235 °	38.906235 °
				-121.807284 °	-121.807284 °
DWR ID	20433				
Comment Code					
Inspector Comment					
DS_ID:20433					
FS_ID:55858					
EP_NO: N/A					
Repair Type: Non-Urgent					
Crossing Status: Found					
UCIP Comments: 9/30/2019 Record updated from No Action Needed to Non-Urgent. No permit for this crossing was found. (O.Yakimov - DWR UCIP)					
FIELD_STRUCT_DESC: 1.5-inch galvanized steel electrical conduit through the levee, at an unknown depth. Provides service to pump on the waterside (WS).					
FS Date: 9/30/2019 1:59:39 PM

View of levee crown at the crossing

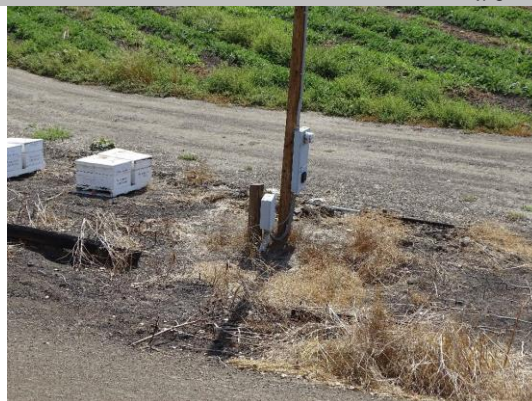
Photo 2 of 3 : UCIP_SP_2020_55858_83115.jpg

Service pole at LS toe

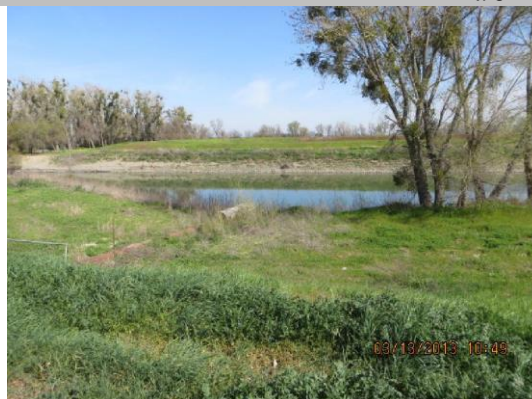
Photo 1 of 2 : UCIP_SP_2020_55860_27169.jpg

Comment Code						
Inspector Comment						
DS_ID:20235 FS_ID:55860 EP_NO: 9354 Repair Type: Non-Urgent Crossing Status: Not Found UCIP Comments: 9/30/2019 Record updated from No Action Needed to Non-Urgent. Crossing not found. Need to have CVFPB review ABO and determine current owner. (O.Yakimov - DWR UCIP) FIELD_STRUCT_DESC: *ABANDONED* [Tysdall Mound Pumping Plant] 1 of 3: 36-inch steel irrigation pipe through the levee, 28 feet below the crown. Slide gates on the waterside (WS) ends. Grouted in place. No above-ground appurtenances remain. (Two 36-inch and one 48-inch pipes authorized under Automatic Board Order (ABO) issued as Permit No. 9354, 1974 - Reclamation District No. 108). [Additional Reference(s): DWR Levee Log, 2006, (HLM 14.53). USACE Sacramento O&M Manual 130, May 1960 (HLM 14.53), listed as two 36-inch pipes with gate on waterside]. FS Date: 9/30/2019 2:47:36 PM

Pipe barrier along WS berm at approximate location of abandoned pumping plant.

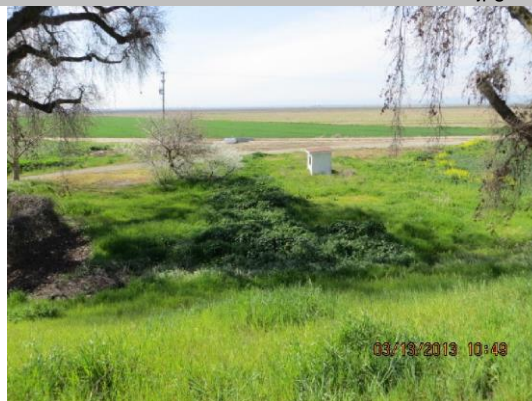
Photo 2 of 2 : UCIP_SP_2020_55860_27168.jpg

Site of abandoned pumping plant.

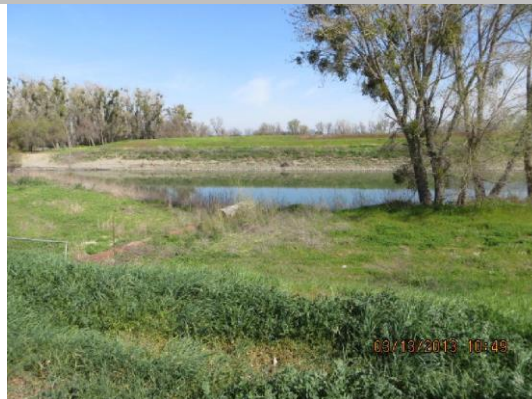
Photo 1 of 2 : UCIP_SP_2020_55861_27171.jpg

Comment Code						
Inspector Comment						
DS_ID:20333 FS_ID:55861 EP_NO: 9354 Repair Type: Non-Urgent Crossing Status: Not Found UCIP Comments: 9/30/2019 Record updated from No Action Needed to Non-Urgent. Crossing not found. Need to have CVFPB review ABO and determine current owner. (O.Yakimov - DWR UCIP) FIELD_STRUCT_DESC: *ABANDONED* [Tysdall Mound Pumping Plant] 2 of 3: 48-inch concrete encased steel irrigation pipe through the levee, 29 feet below the crown. Slide gate on the waterside (WS) end. Grouted in place. No above ground appurtenances remain. (Permit No. 9354, 1974 - Reclamation District No. 108). [Additional Reference(s): DWR Levee Log, 2006, (HLM 14.53). USACE Sacramento O&M Manual 130, May 1960 (HLM 14.53), listed as 48-inch pipe with gate on watreside]. FS Date: 9/30/2019 2:49:03 PM

Location of abandoned pumping plant to left of tree.

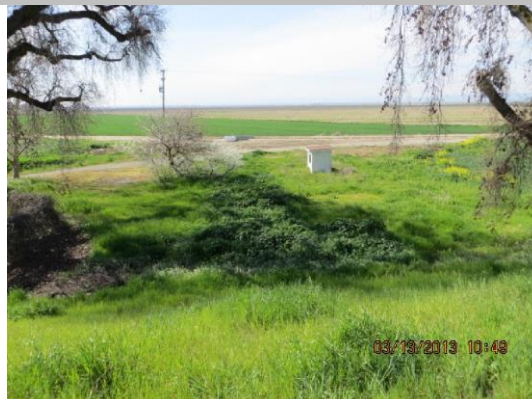
Photo 2 of 2 : UCIP_SP_2020_55861_27170.jpg

Location of abandoned pumping plant between large trees.

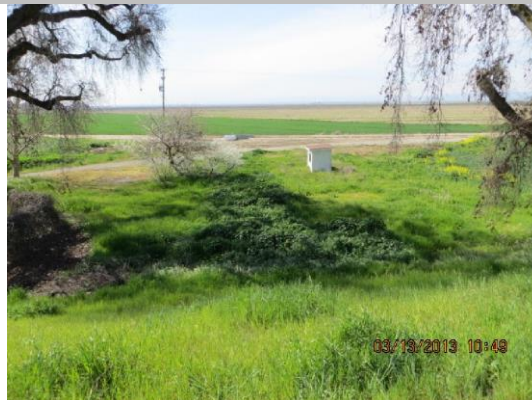
Photo 2 of 2 : UCIP_SP_2020_55862_27172.jpg

Comment Code						
Inspector Comment						
DS_ID:20236						
FS_ID:55862						
EP_NO: 2887						
Repair Type: Non-Urgent						
Crossing Status: Not Found						
UCIP Comments: 9/30/2019 Record updated from No Action Needed to Non-Urgent. Crossing not found. (O.Yakimov - DWR UCIP)						
FIELD_STRUCT_DESC: *ABANDONED* [Tysdall Mound Pumping Plant] 16-inch steel irrigation pipe through the levee, 2.7 feet below the crown. Vertical pump on the waterside (WS) end. Siphon breaker on the landside (LS) shoulder. (16-inch pipe authorized under Permit No. 2887, 1958 - Reclamation District No. 108). Grouted in place. No above-ground appurtenances remain. [Additional Reference(s): DWR Levee Log, 2006, (HLM 14.53)].						
FS Date: 9/30/2019 2:49:21 PM

Location of abandoned pumping plant LS.
